# NEPTUNE AMBIENT AIR QUALITY MONITORING ANNUAL REPORT

## NEPTUNE BULK TERMINALS LTD.

Report Date: March 31<sup>st</sup>, 2021

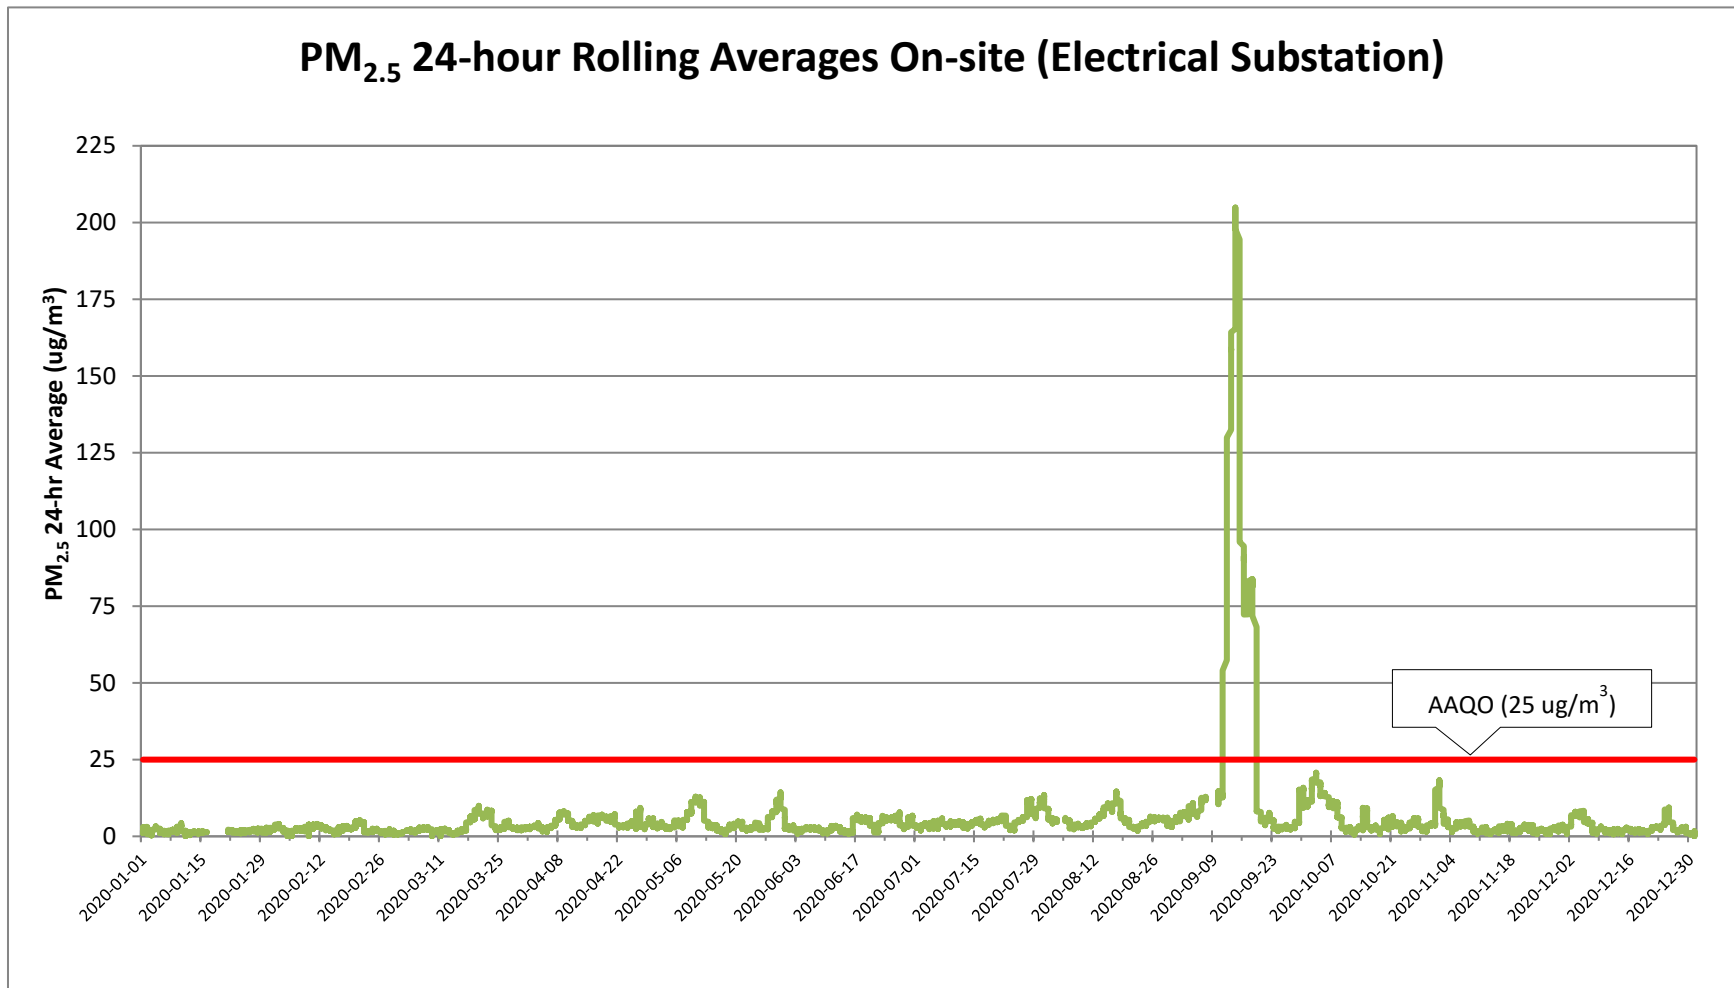
Figure 2: 24-hour rolling averages of PM<sub>2.5</sub> from on-site monitor (Electrical Substation) for Jan 1<sup>st</sup> – Dec 31<sup>st</sup>, 2020

The trend analyses represent 24-hour rolling averages of PM<sub>2.5</sub> and PM<sub>10</sub> data measured on-site (Electrical Substation), at the Neptune Office Building (340 Brooksbank Ave.), and at 618 2<sup>nd</sup> St. East. Any gaps in the trend analyses are due to missing or invalid data.

The on-site and off-site PM<sub>2.5</sub> and PM<sub>10</sub> ambient air quality monitors showed a few AAQO exceedances in 2020. The only exceedances at the off-site monitors were during September and were primarily caused by wildfire smoke entering the region from the United States (exceedances were observed across the region). Outside of this period, the only other exceedances were of the PM<sub>10</sub> objective at the on-site air quality monitor in May which were likely due to other off-site sources in the area. These exceedances were discussed in more detail in the quarterly ambient air quality monitoring reports.

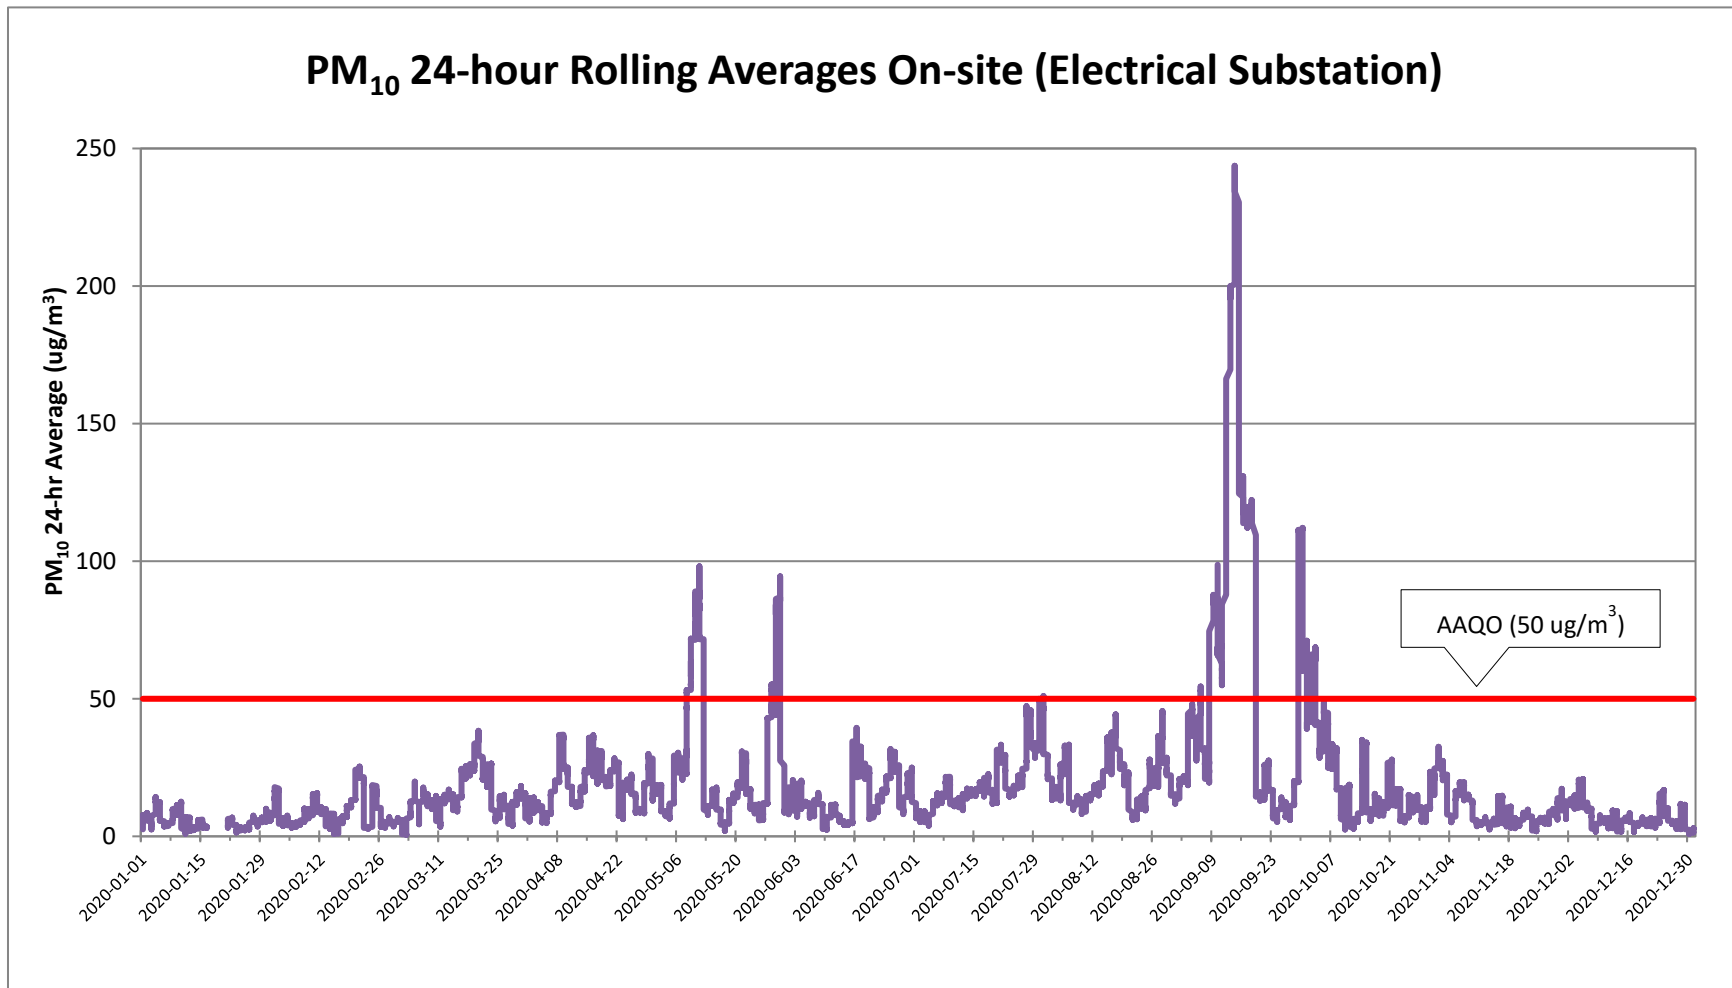
Figure 3: 24-hour rolling averages of PM<sub>10</sub> from on-site monitor (Electrical Substation) for Jan 1<sup>st</sup> – Dec 31<sup>st</sup>, 2020

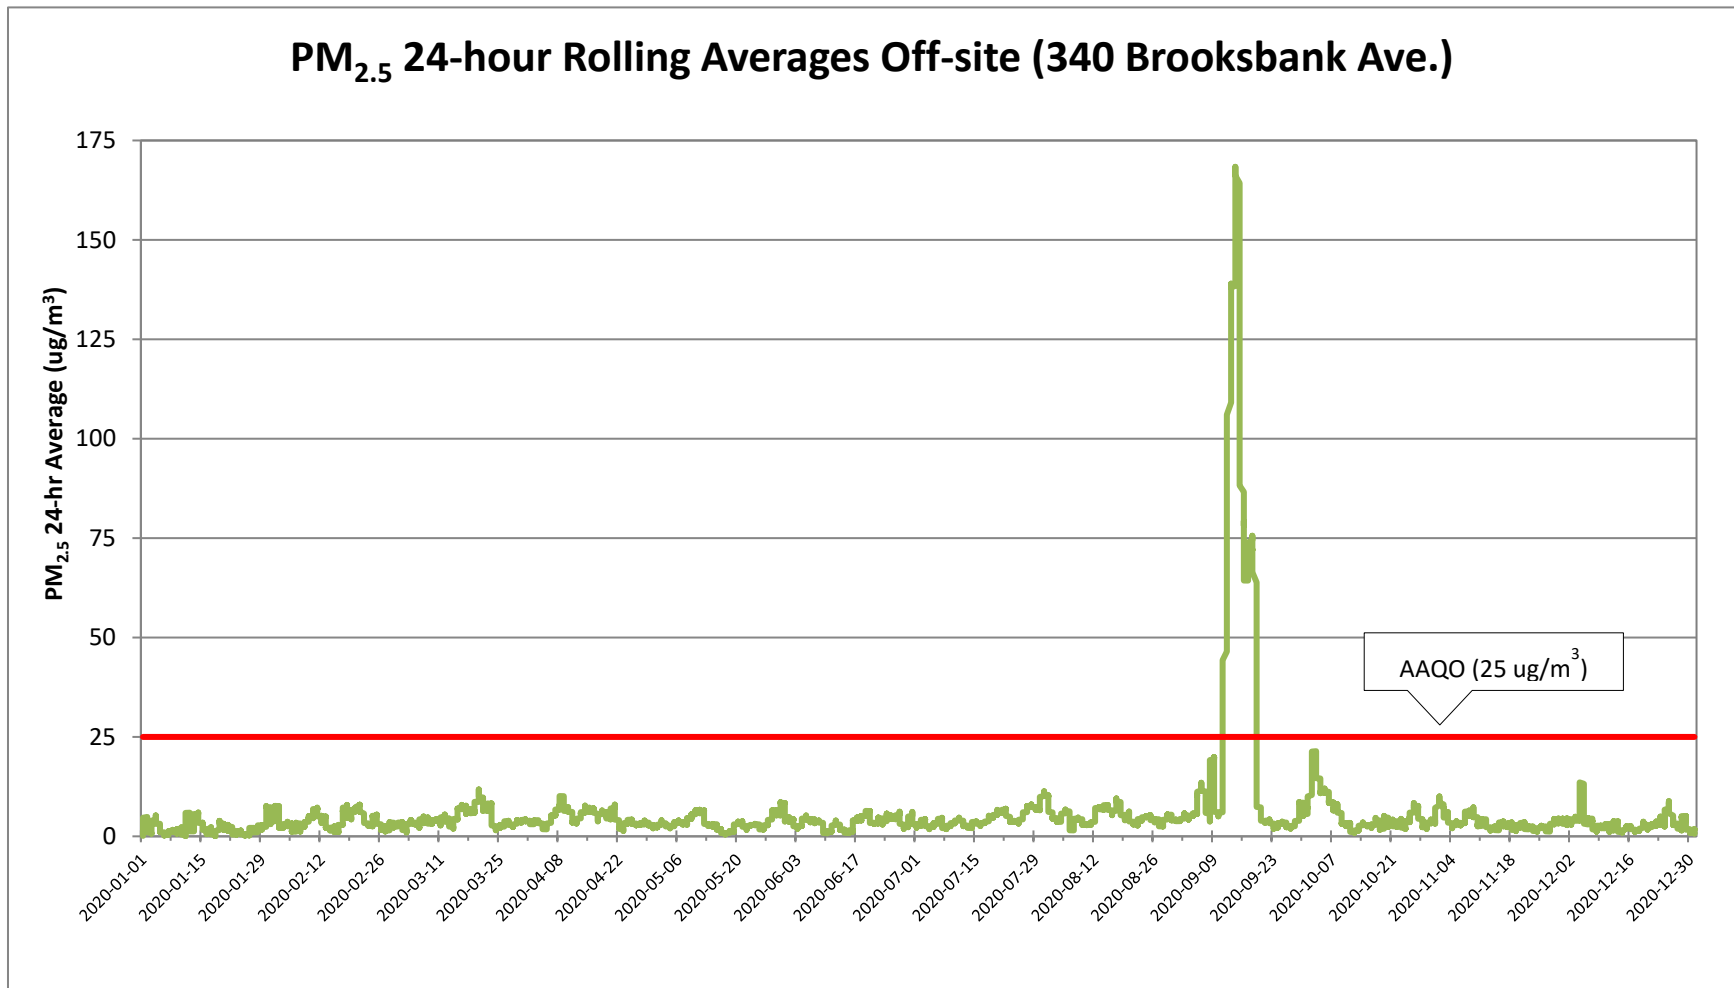
Figure 4: 24-hour rolling averages of PM<sub>2.5</sub> from off-site monitor at the Neptune Office Building (340 Brooksbank Ave.)  
for Jan 1<sup>st</sup> – Dec 31<sup>st</sup>, 2020

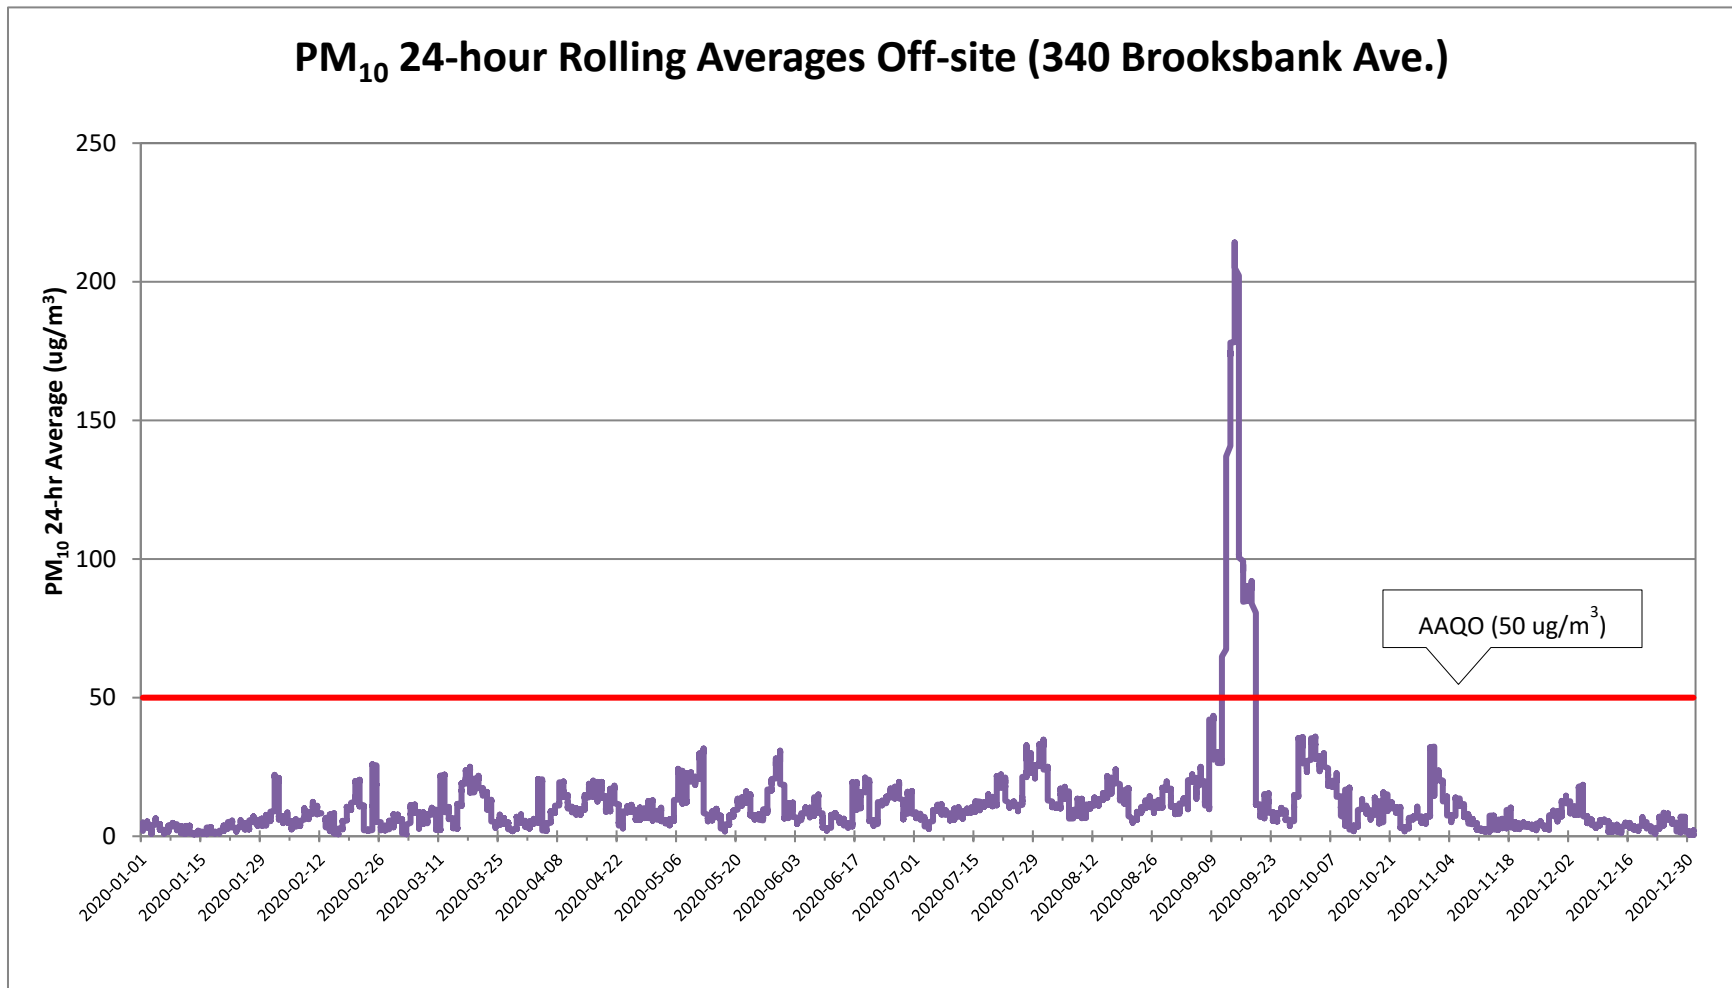
**Figure 5: 24-hour rolling averages of PM<sub>10</sub> from off-site monitor at Neptune Office Building (340 Brooksbank Ave.)  
for Jan 1<sup>st</sup> – Dec 31<sup>st</sup>, 2020**

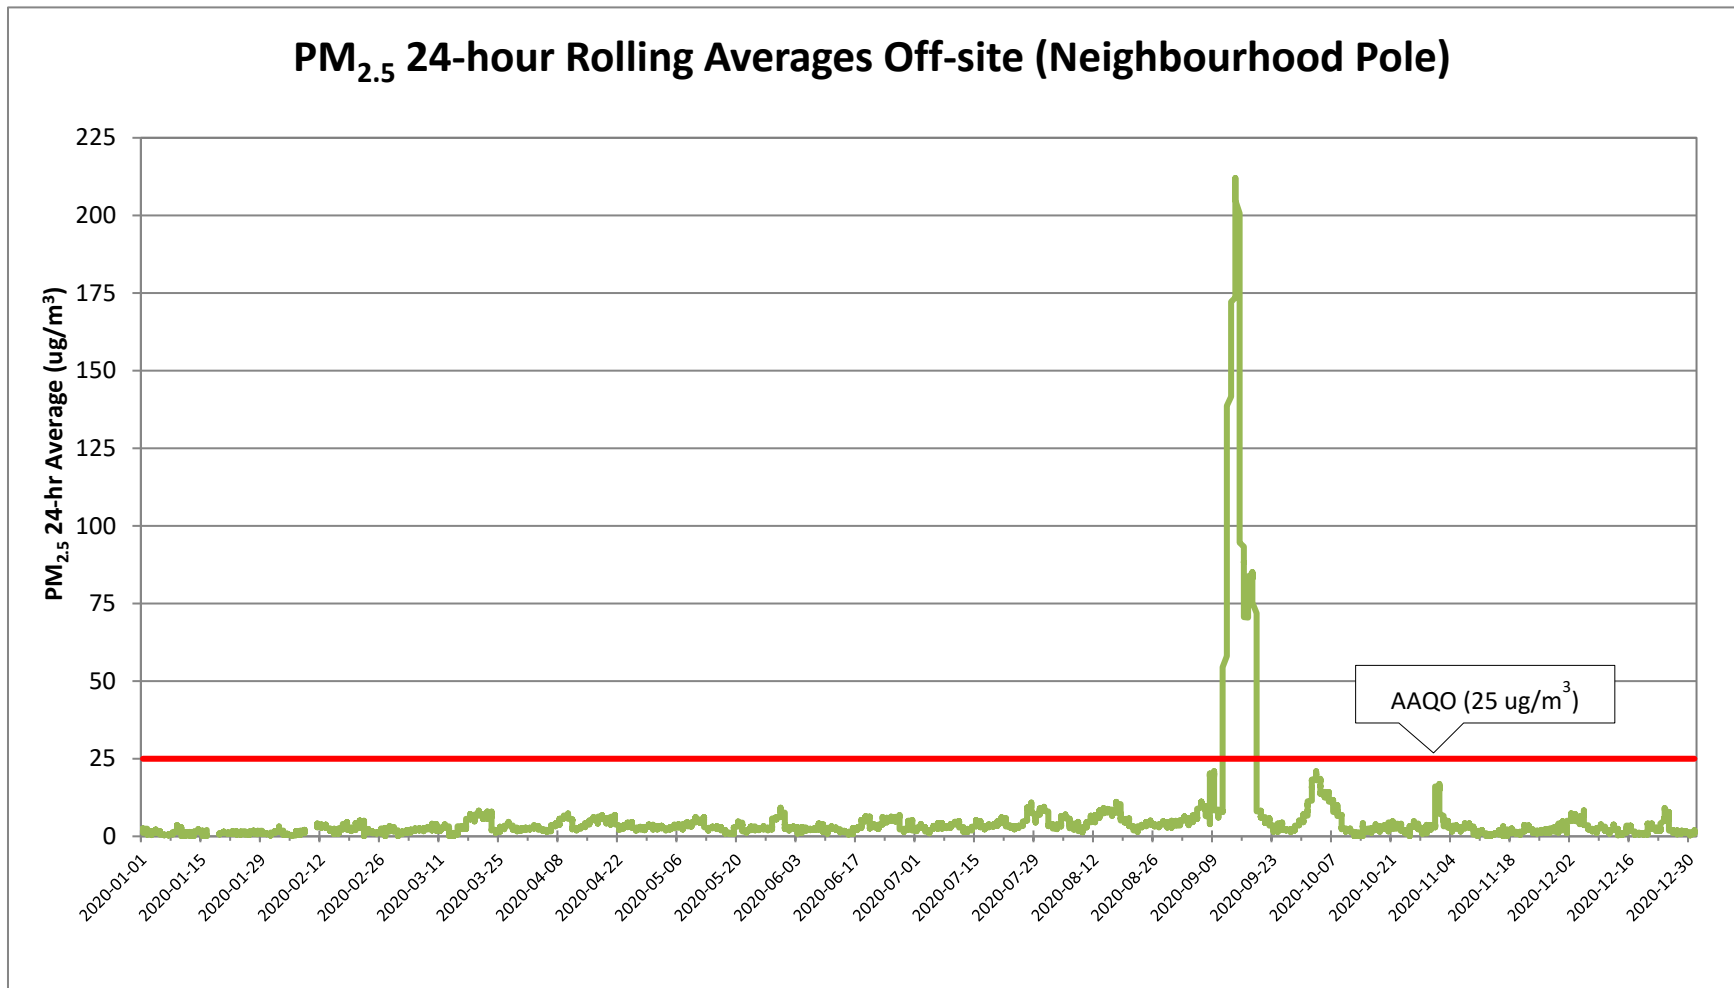
Figure 6: 24-hour rolling averages of PM<sub>2.5</sub> from off-site monitor at 618 2<sup>nd</sup> St. East for Jan 1<sup>st</sup> – Dec 31<sup>st</sup>, 2020

It should be noted that there was heavy construction around the neighbourhood pole monitor (618 2<sup>nd</sup> St. East) during 2020.

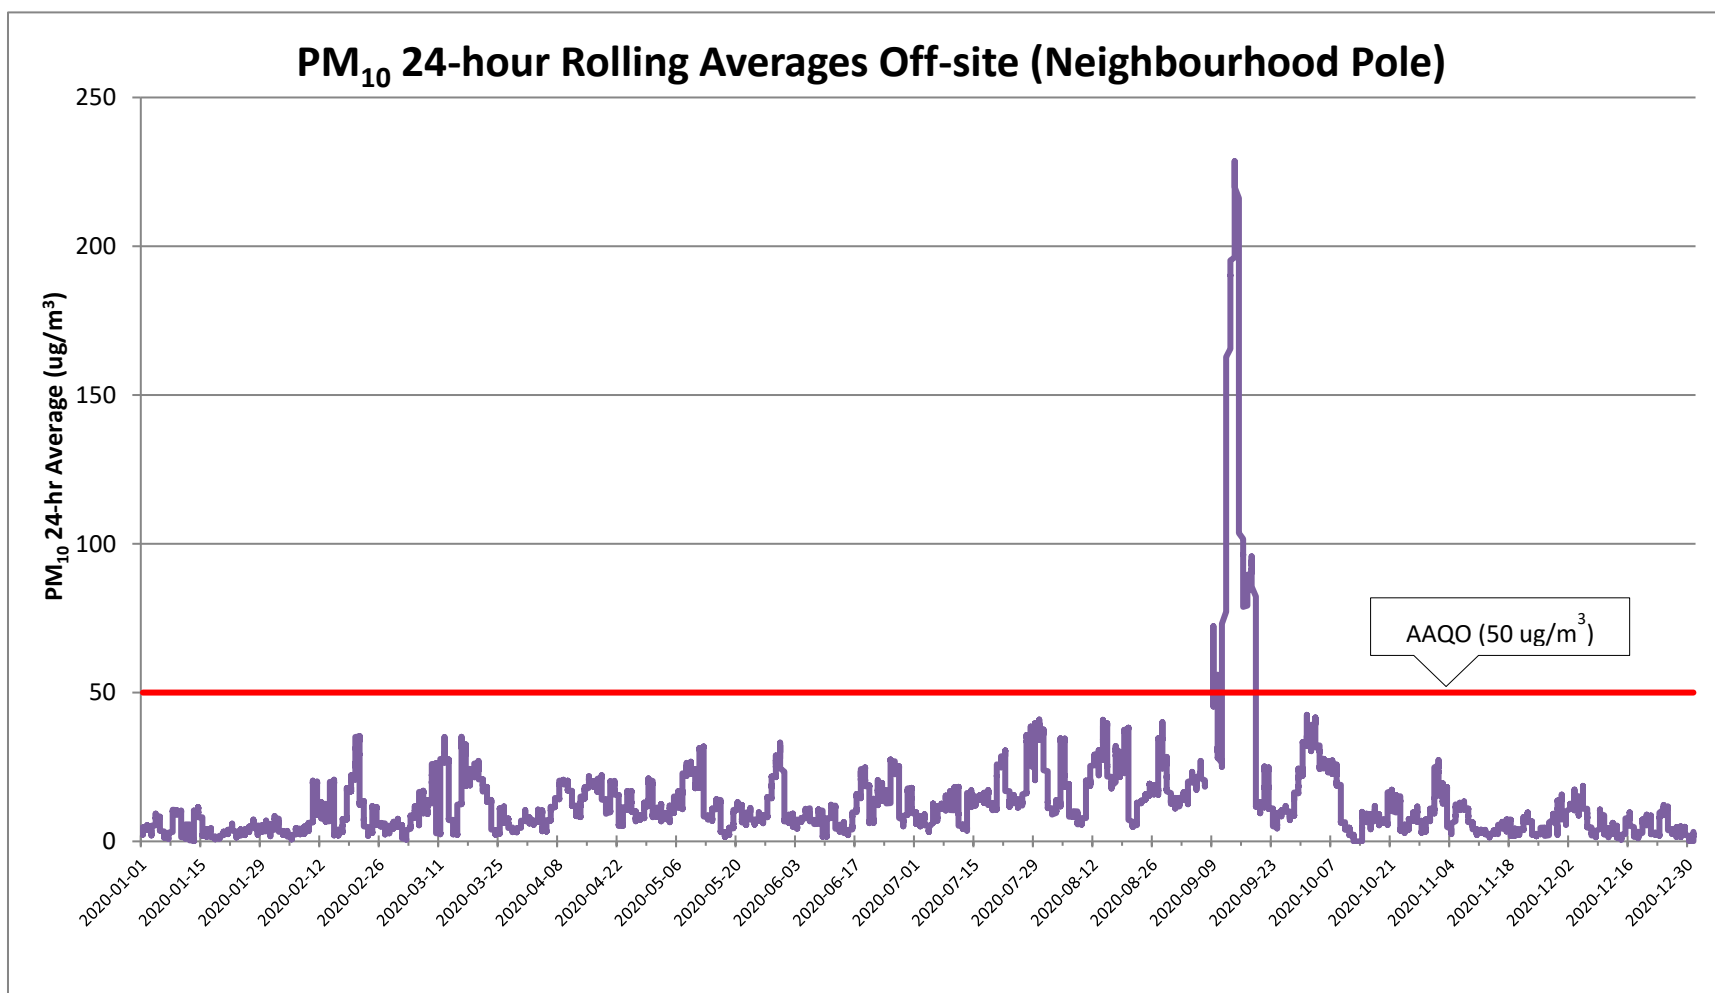
Figure 7: 24-hour rolling averages of PM<sub>10</sub> from off-site monitor at 618 2<sup>nd</sup> St. East for Jan 1<sup>st</sup> – Dec 31<sup>st</sup>, 2020

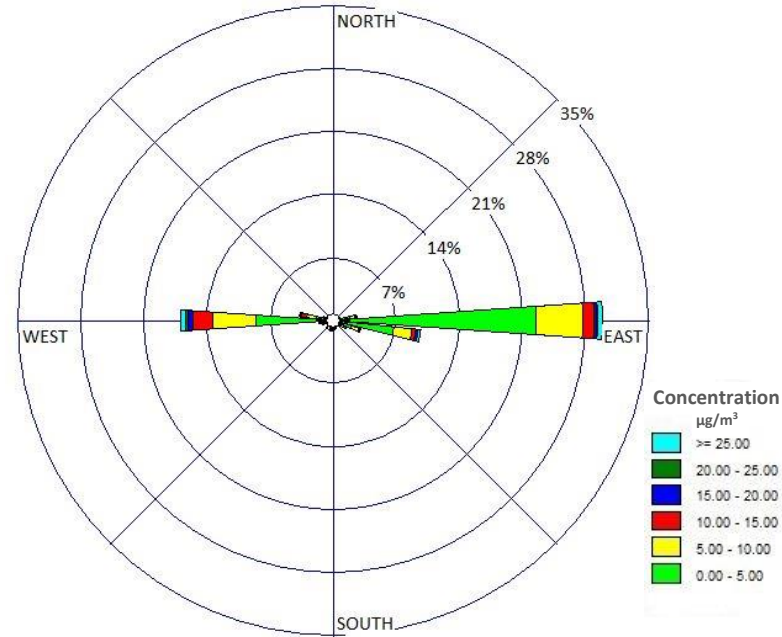
PM<sub>2.5</sub> Pollution Rose at Neptune Electrical Substation

Figure 8: Pollution roses (direction wind blowing from) at on-site and off-site monitoring stations for Jan 1<sup>st</sup> – Dec 31<sup>st</sup>, 2020

Pollution roses are shown in **Figure 8** and the frequency distributions are shown in **Figure 9**. The pollution roses and frequency distributions represent the distribution of wind direction temporally correlated with PM<sub>2.5</sub> and PM<sub>10</sub> concentrations at the on-site (Electrical Substation) and off-site monitors (roof of Neptune Office Building and pole mounted at 618 2<sup>nd</sup> St. East) for 2020.

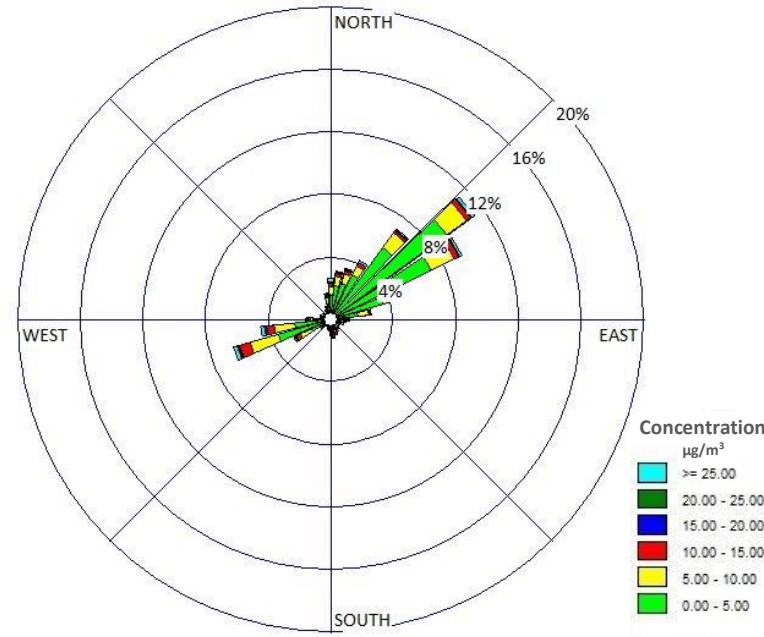
PM<sub>2.5</sub> Pollution Rose at Neighbourhood Pole (618 2<sup>nd</sup> St. East)

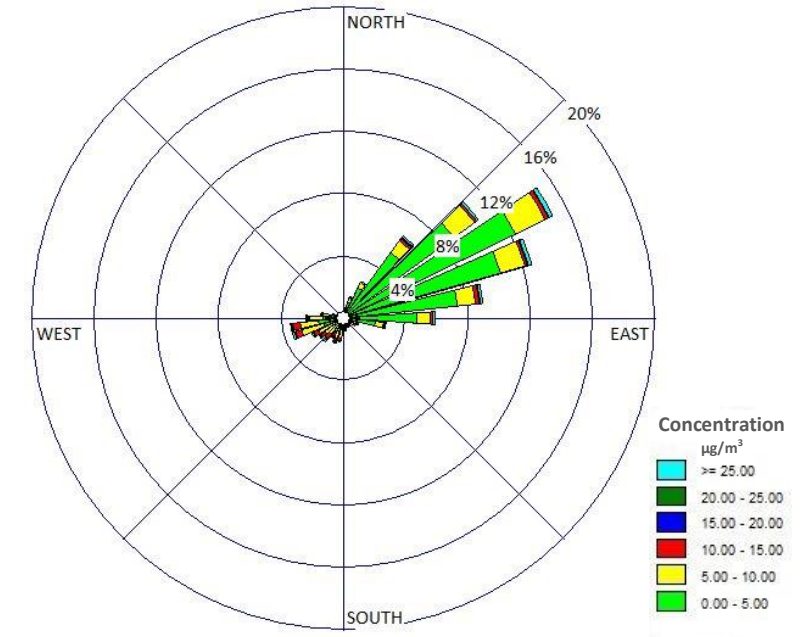
PM<sub>2.5</sub> Pollution Rose at Neptune Office Building (340 Brooksbank Ave.)<sup>(a)</sup>

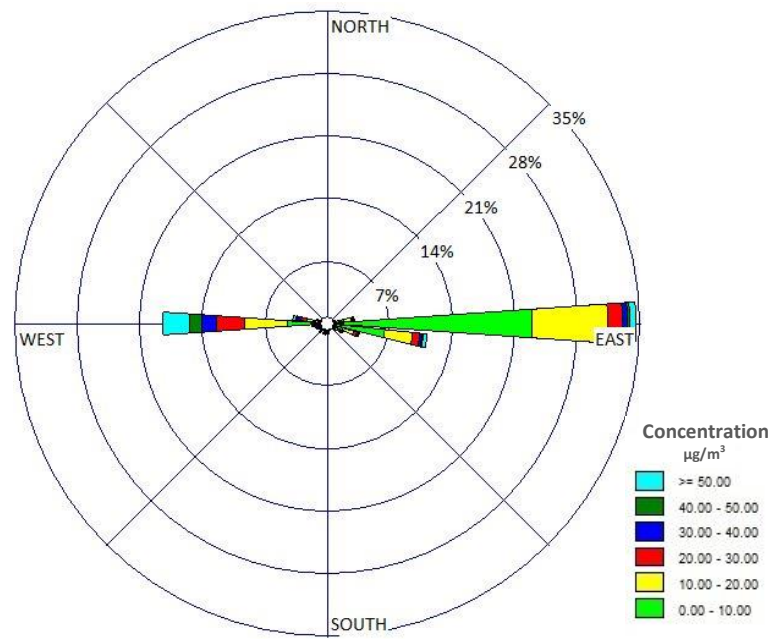
PM<sub>10</sub> Pollution Rose at Neptune Electrical Substation

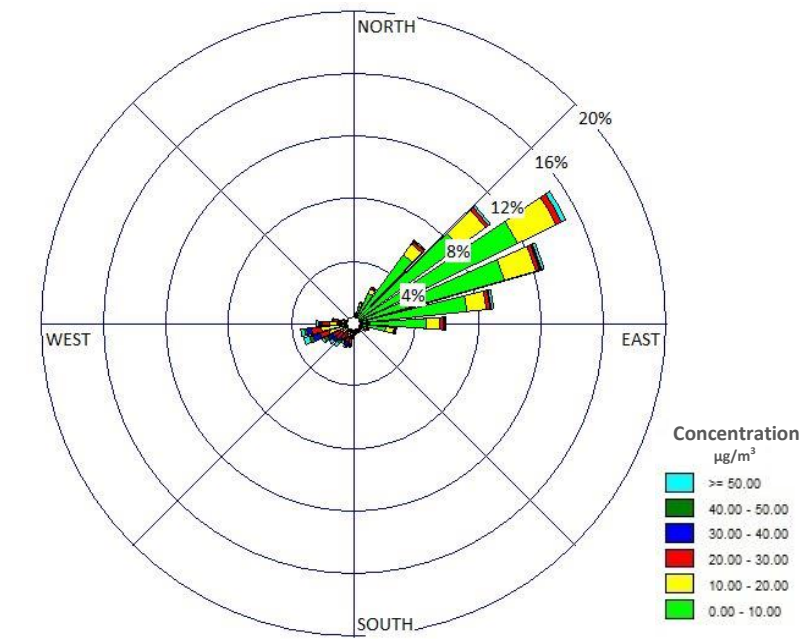
PM<sub>10</sub> Pollution Rose at Neptune Office Building (340 Brooksbank Ave.)
